Efforts to Ensure Levee Reliability

Director, River Management Office,
River Improvement and Management Division,
River Bureau

- Characteristics of levees in Japan
- Structural standards for levees
- Safety verification method for levees
(seepage, erosion, earthquake resistance)
- Monitoring of levees
(feedback from maintenance)

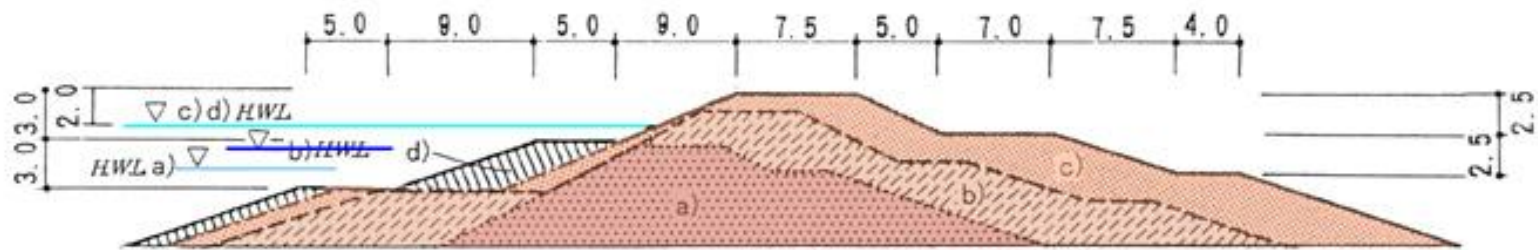
Historical changes in the cross section of the Edo River

Levees that we see today are the results of various strengthening works carried out over many years.

- a) Improvement Plan (1911)
- b) Augmentation Plan (1939)
- c) Modified Improvement Plan (1949)
- d) New Modified Improvement Plan (1980)

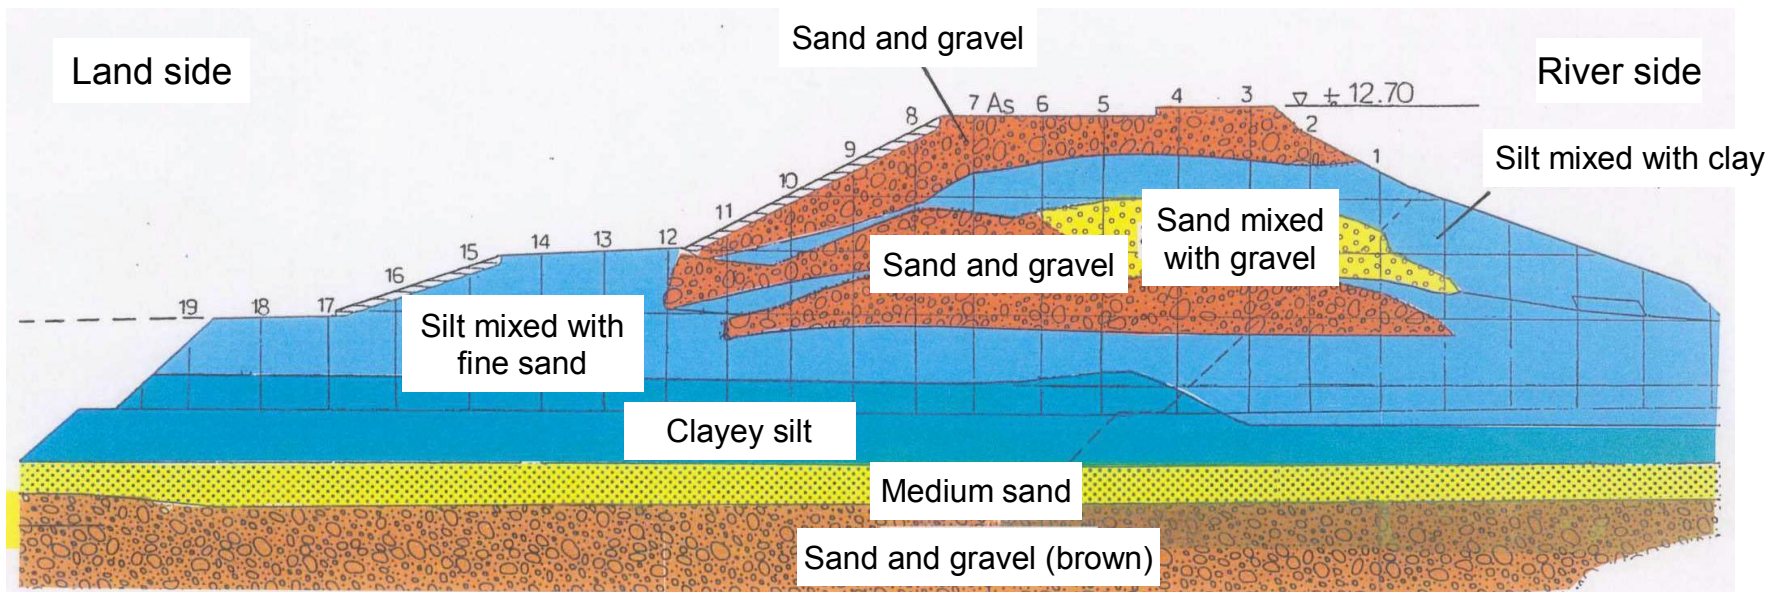
Complexity of levee materials

Levees have been built mainly with locally available materials. Consequently, soil types (levee materials) and construction methods (e.g., compaction) used are diverse.

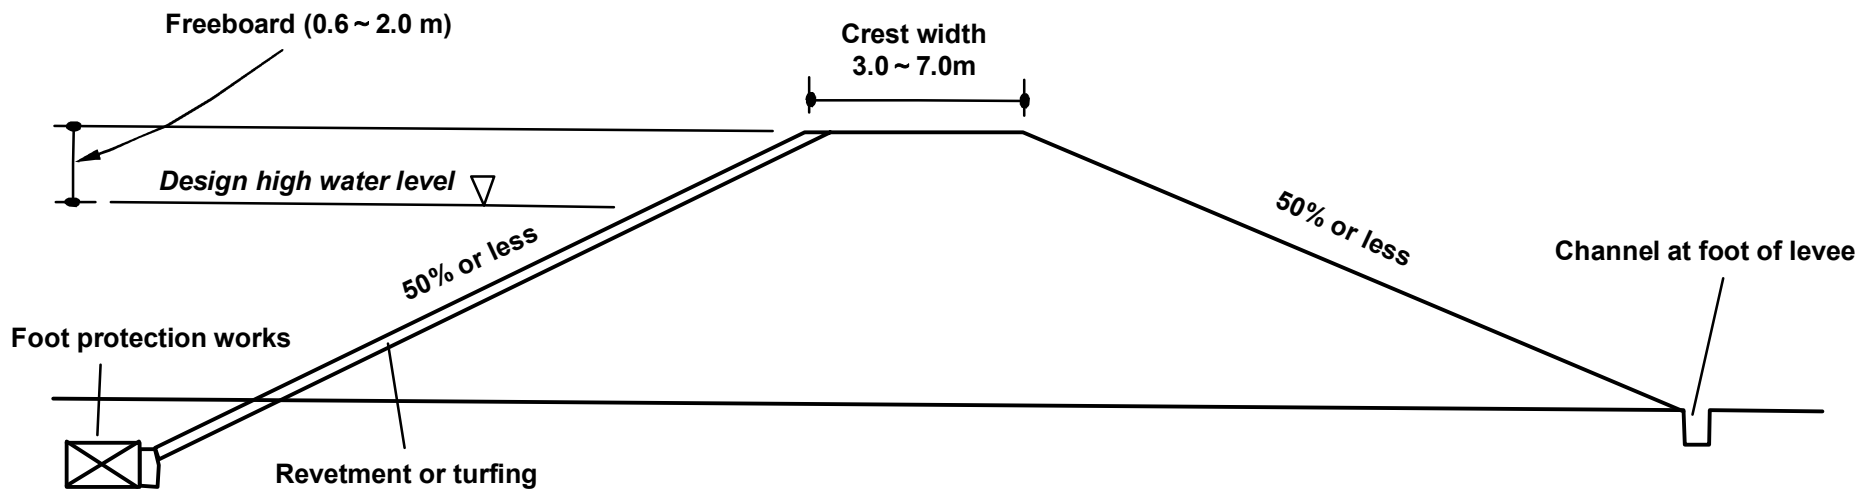
Standard Levee Structure Conforming to Cabinet Order Concerning Structural Standard for River Administration Facilities, Etc.

- Safe structure against the action of flowing water at or below HWL
- Earth levee (as a general rule)
- Height (height over HWL to be determined according to streamflow)
- Crest width (specified according to streamflow)
- Slope gradient: 50% or less; slope protection by turfing, etc.

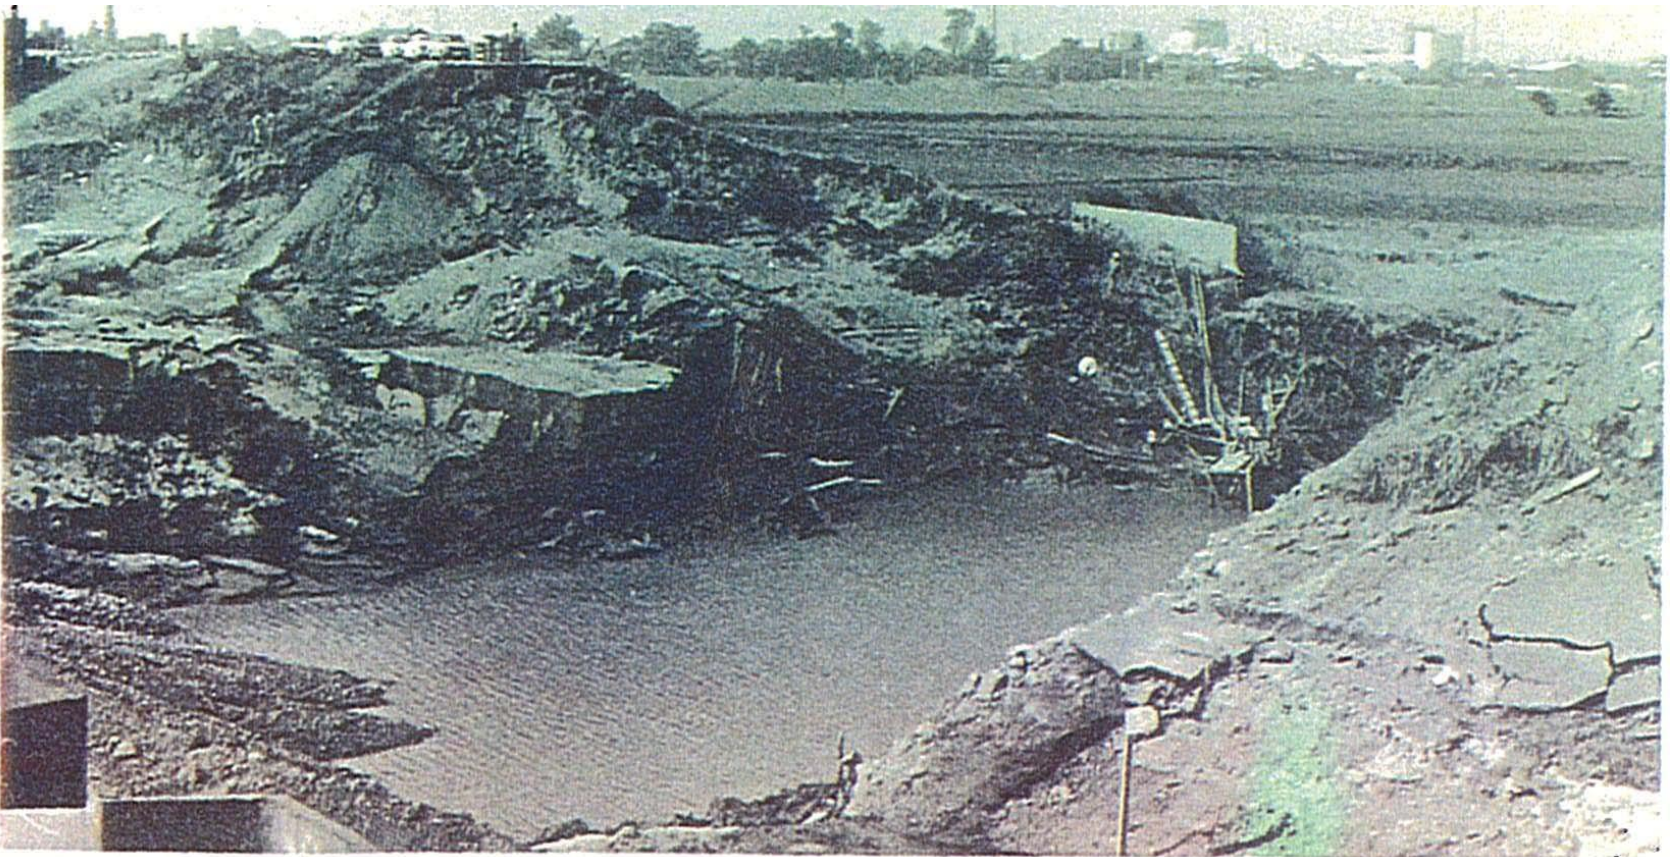
Nagara River, 1976

Design of Levees against Seepage

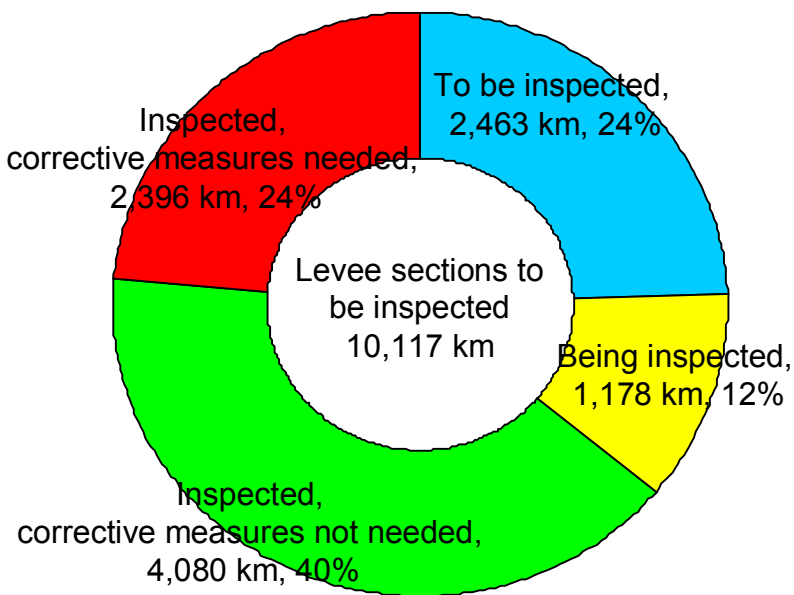
State of Levee Inspection for Seepage Safety (State-managed Rivers, 2002 ~)

As of the end of December,
2006

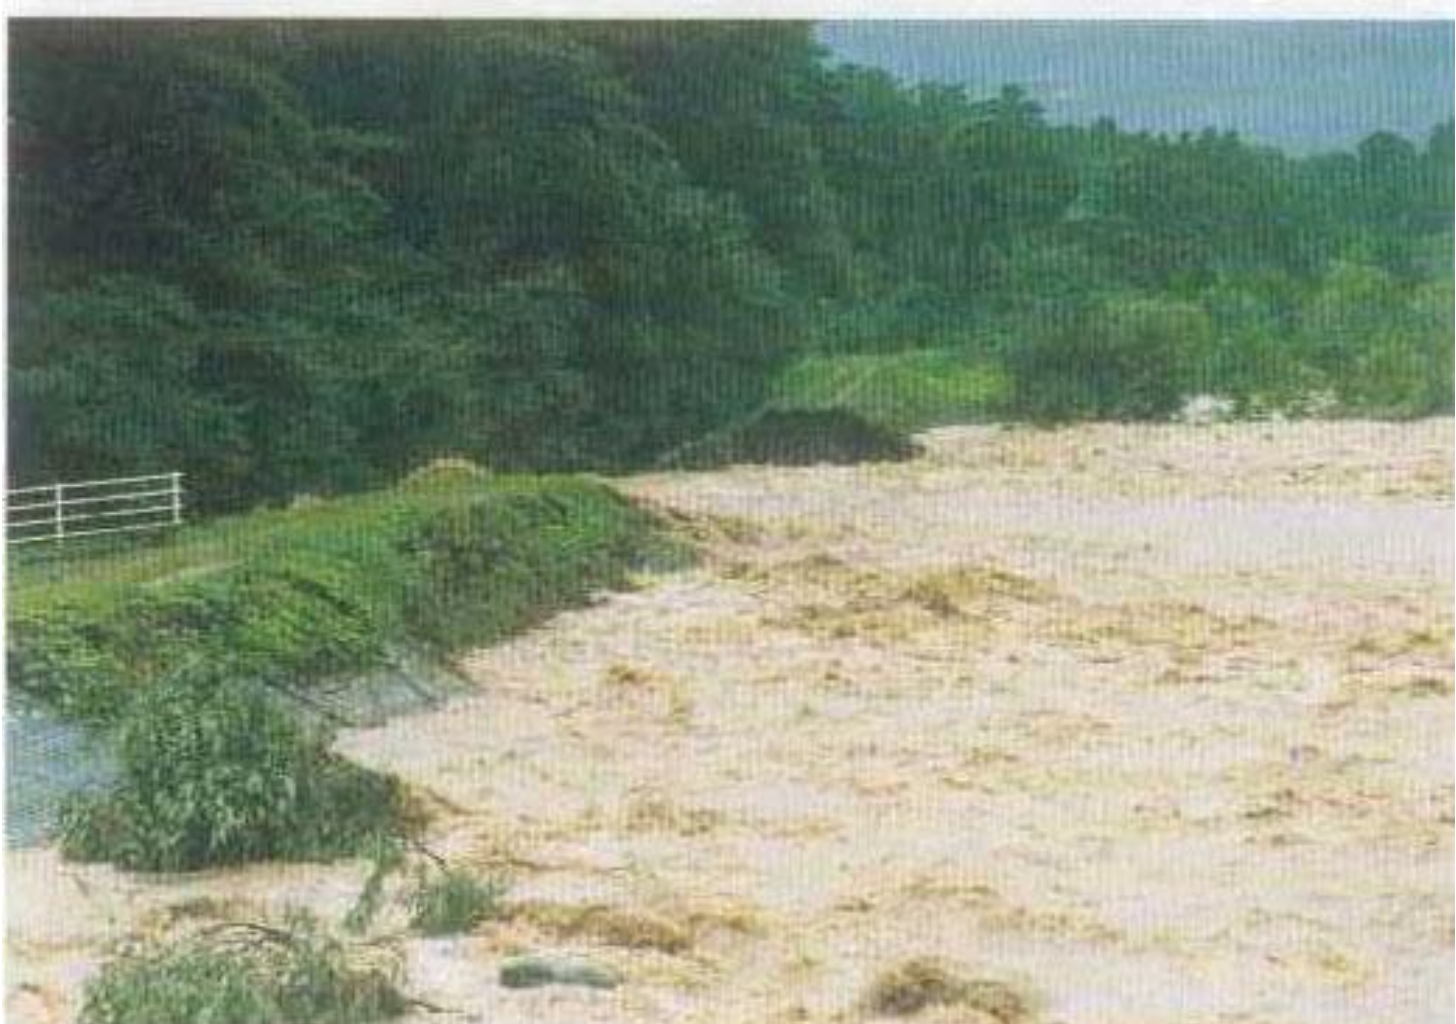
Ara River, 1998

Levee Design against Erosion

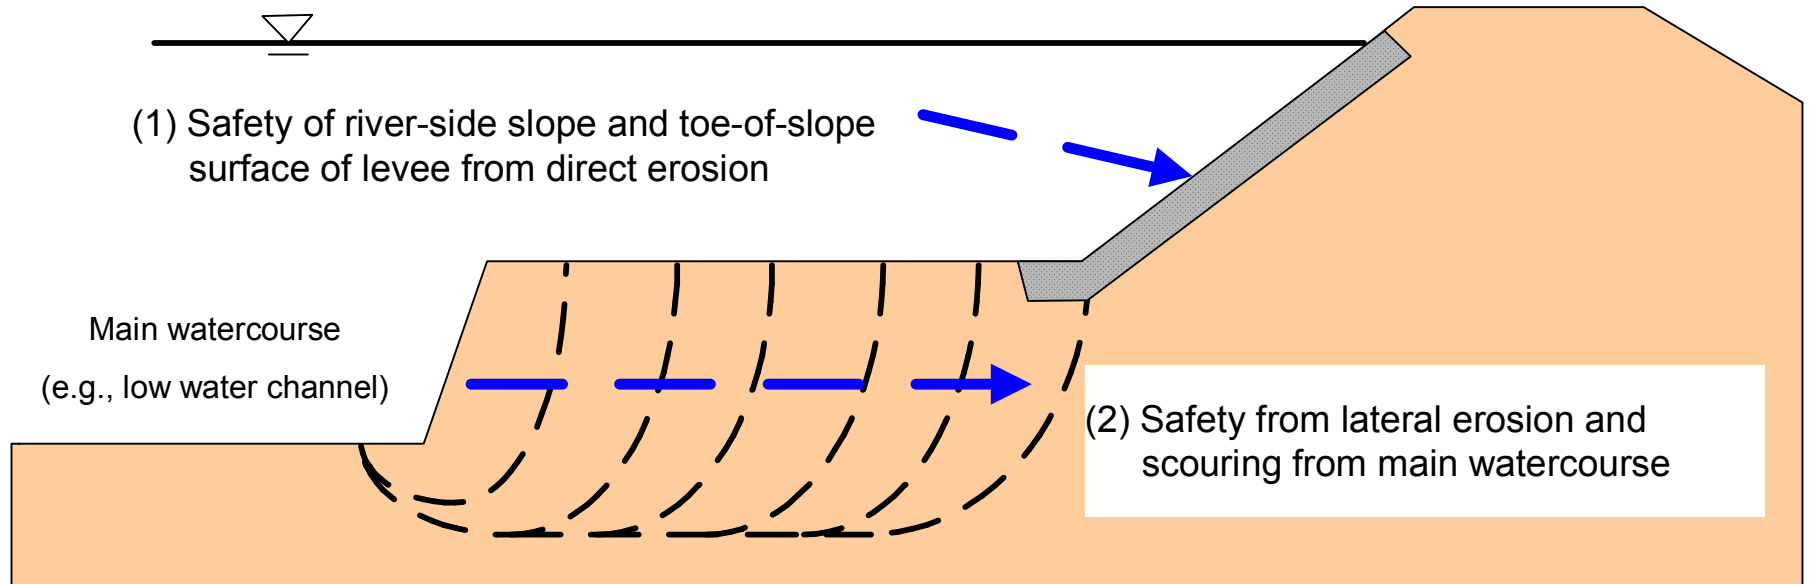
External Forces for Erosion Safety Verification and Verification Criteria

External forces for verification

- Setting **representative flow velocity**: calculated by multiplying the highest average flow velocity by a correction factor for curvature, etc.

- (1) Safety from direction erosion of river-side slope and toe-of-slope surfaces of levee
 - **Surface erosion resistance > erosional force calculated from representative flow velocity**
- (2) Safety from lateral erosion and scouring from main watercourse
 - **Width of high water channel > width of high water channel eroded during verification period**

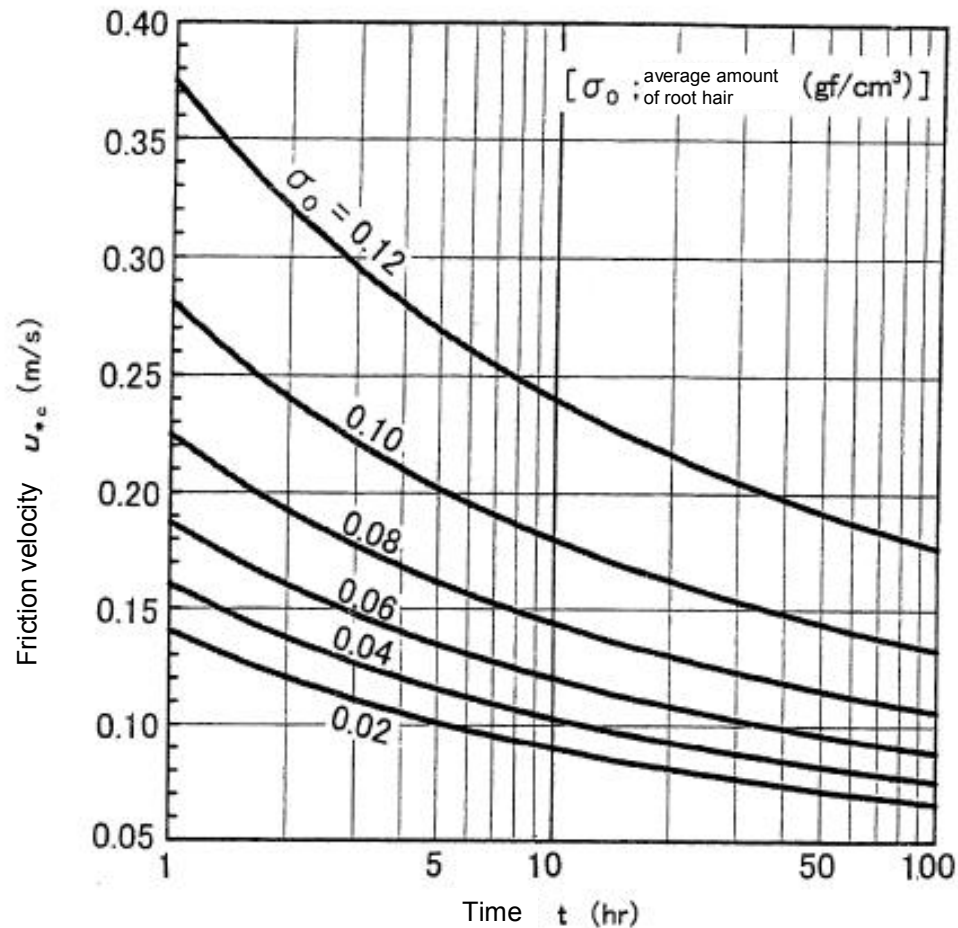
Surface Erosion Resistance

Surface erosion resistance of vegetation
(relationship between the amount of root hair and friction velocity)

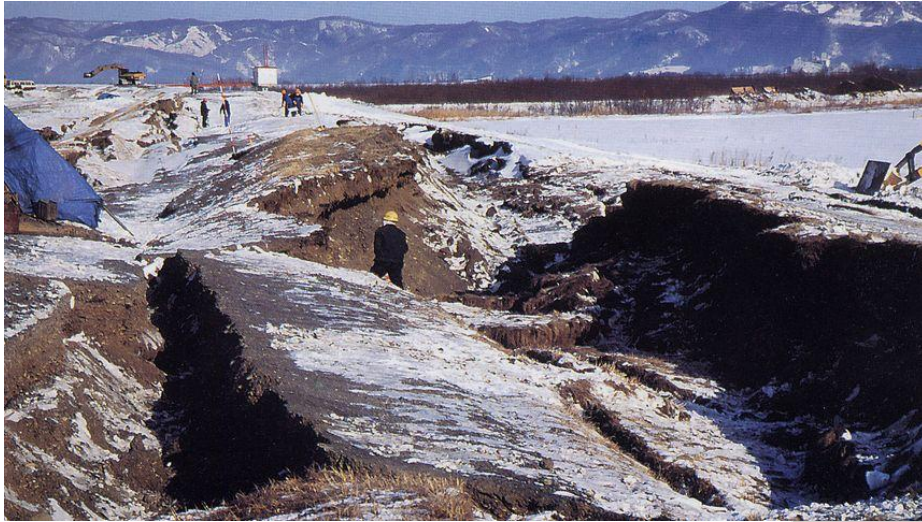
Kushiro-oki Earthquake,
Tokachi River, 1993

Seismic Design of Levees

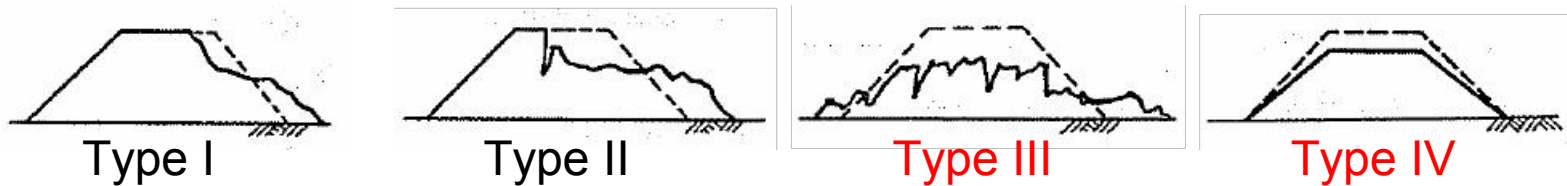
Assumed Types of Levee Deformation and Verification Criteria

- **Type III and type IV deformations are assumed** because the levee crest could become lower than the river-side water level and emergency restoration is difficult to achieve.

- It is confirmed that **the post-quake crest level is higher than the river-side water level (maximum water level in normal times) determined for seismic performance verification.**
